Report No. CMEC 15-009
Test Evaluation of Post-Frame Building Product

Solid Structures, Inc.
6724 N Pittsburg St
Spokane, WA 99217

Composite Materials and Engineering Center
Washington State University
22 May, 2015

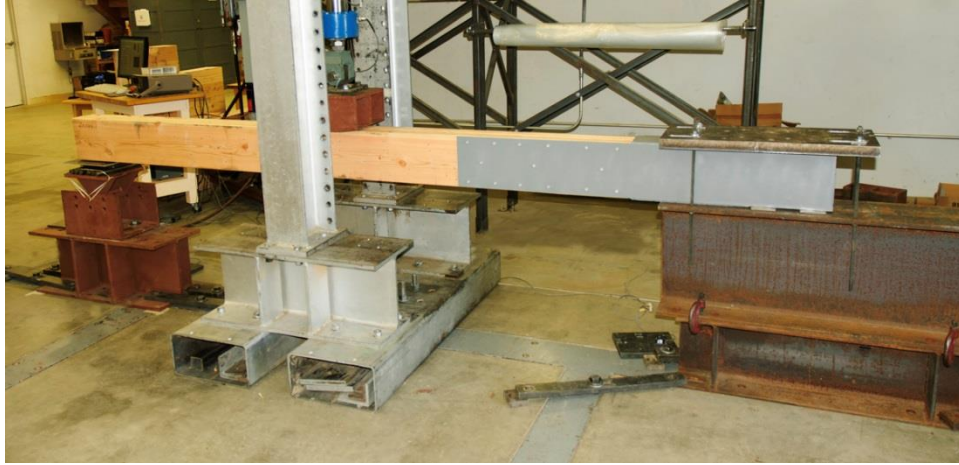
Figure 2. Typical propped cantilever test setup.

Two types of loading were conducted. A propped cantilever test (Figure 2) and a cantilever test (Figure 3) were conducted on ten and four specimens, respectively. The support span for the propped cantilever test was 120 inches and the load was applied at the mid-span using a rounded loading fixture that had a 58-inch diameter. The reaction support on the fixed end of the system was wide enough to prevent damaged to the specimen at the point of contact and the post bracket was secured in place using four lengths of high strength threaded rod. The support apparatus at the propped end of the system included a bearing plate, rollers and a pivot point that provided uniform support across the width of the specimen and ensured unrestricted longitudinal deformation of the beam at the reaction. For the cantilever test setup the reaction support at the propped end of the system was removed to allow the beam to deflect as necessary. The specimens were loaded at a constant rate a displacement (0.6 in/min) until failure. Deflection at the neutral axis of the beam was measured and recorded at 0.5 second intervals at the midpoint of the beam and at the reaction point on each end of the beam. The load imparted into the system was measured and recorded at 0.5 second intervals throughout each test.

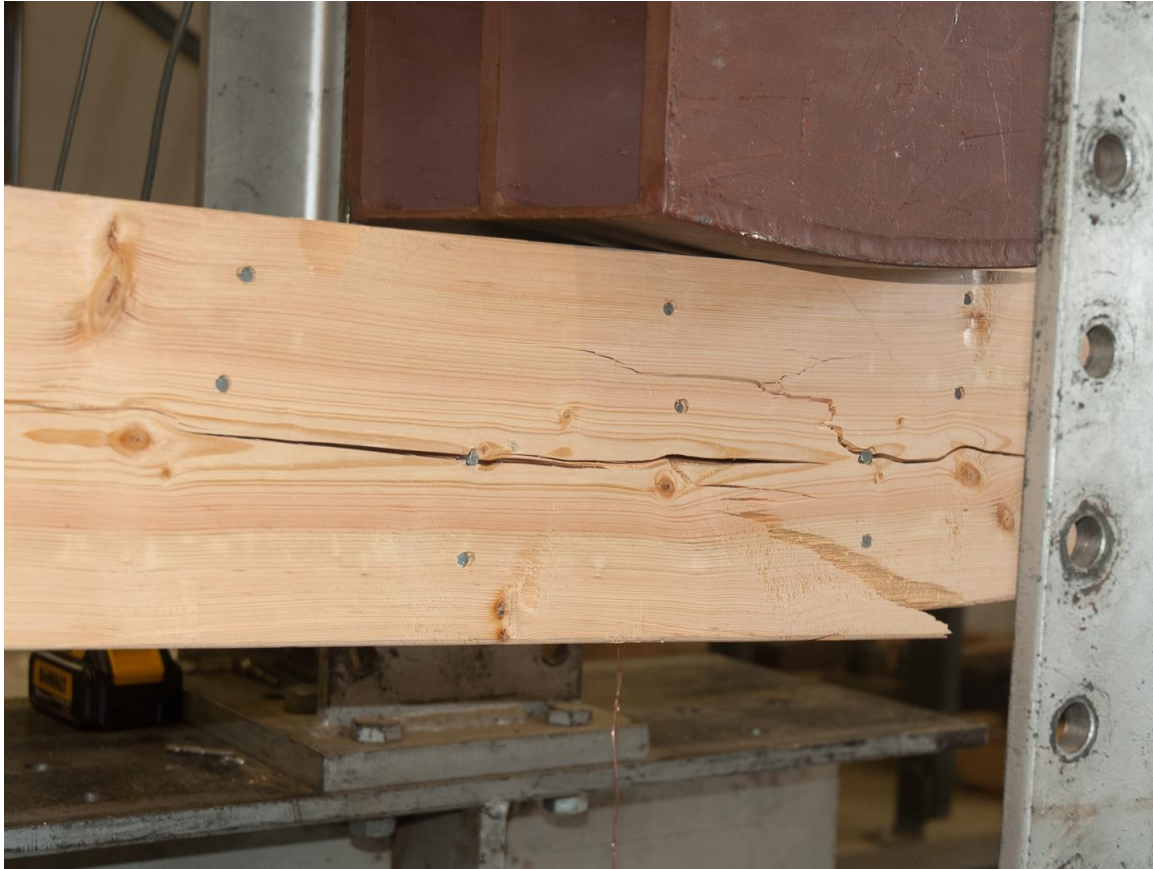
Figure A1. 2x8-4 ply bending failure initiating on tension failure.

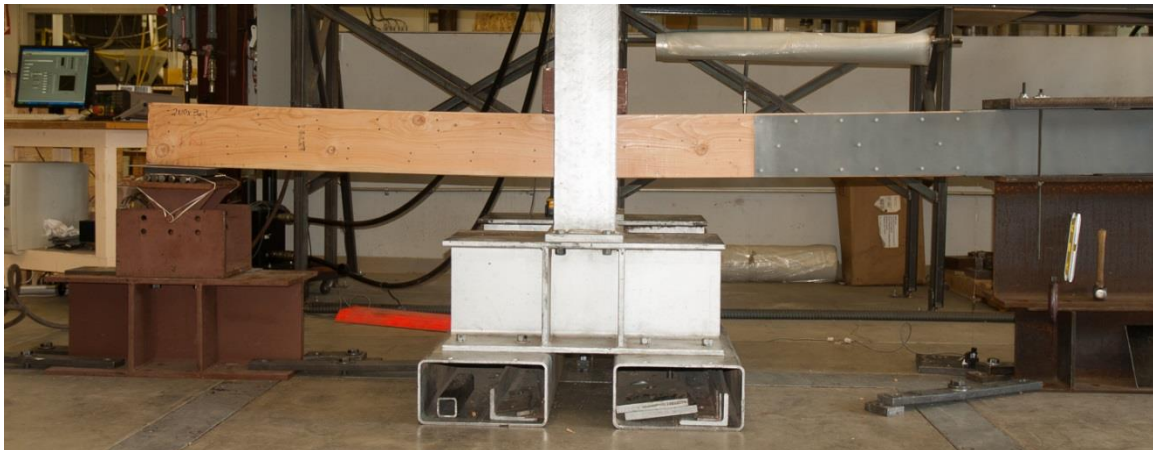
Figure A2. 2x10-3 ply shortly before failure.

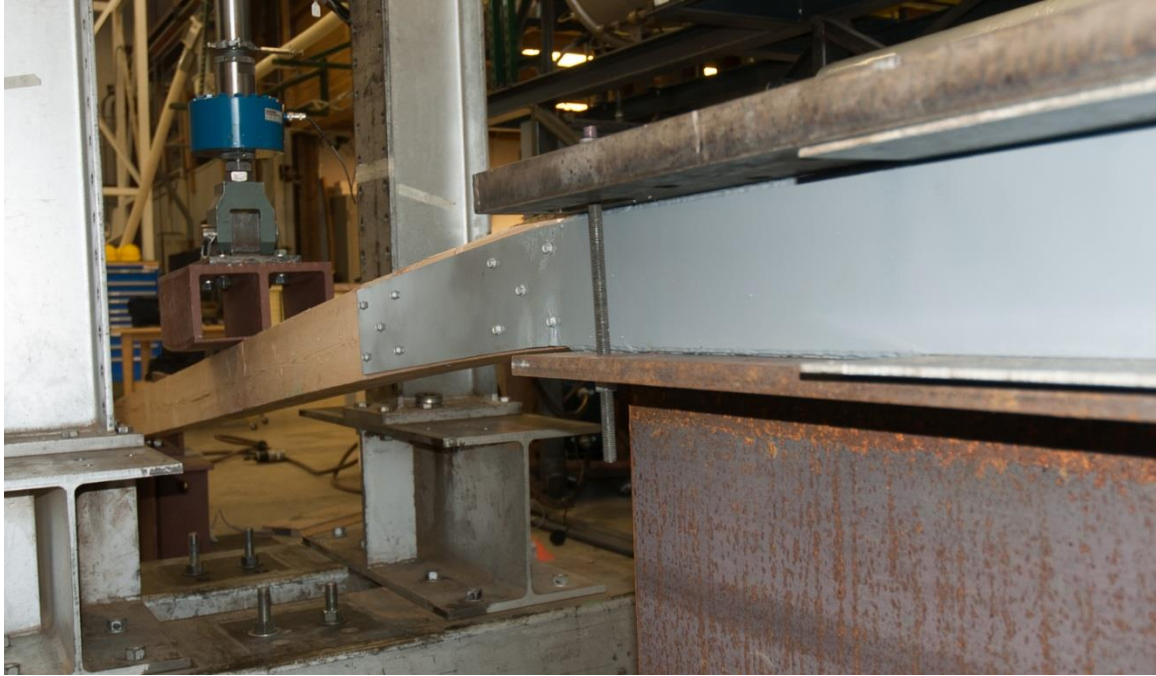
Figure A3. Cantilever after steel yielding.

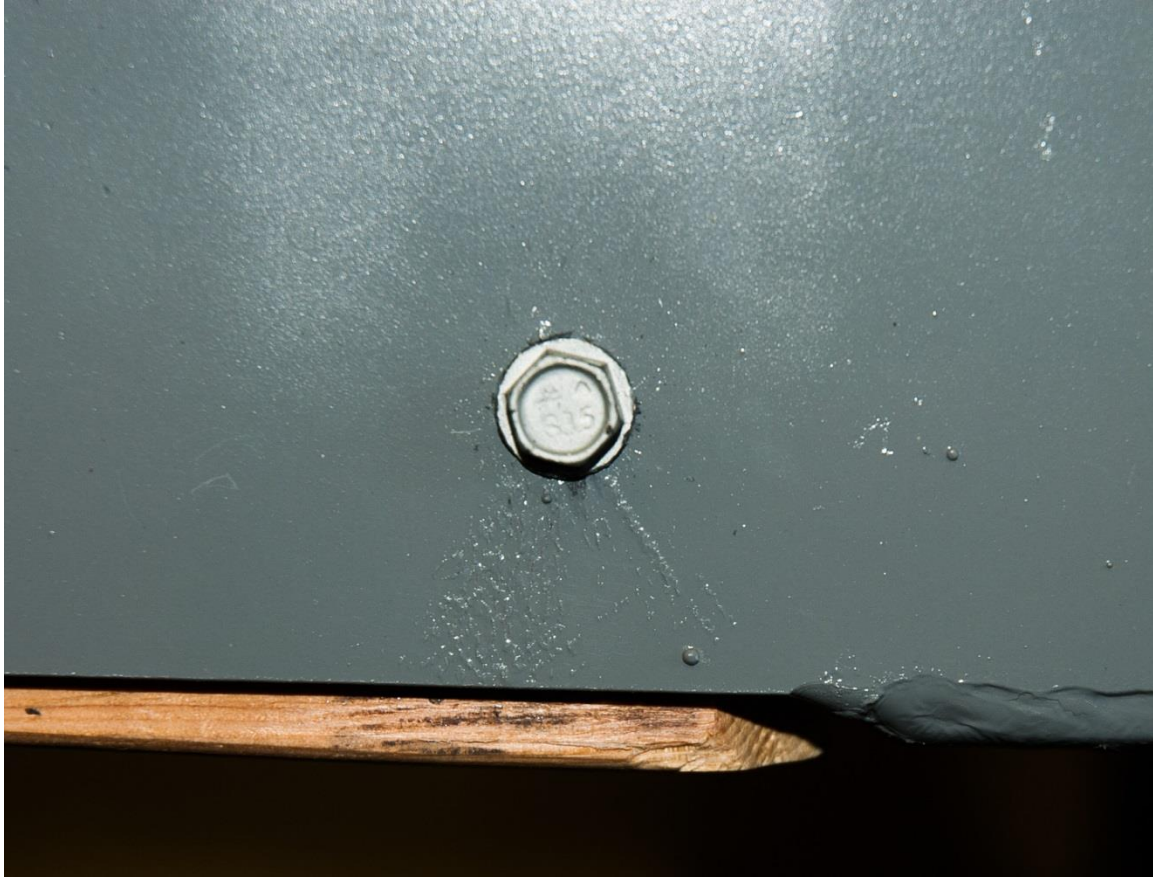
Figure A5. Yielded steel on 2x6-3 ply propped cantilever test.

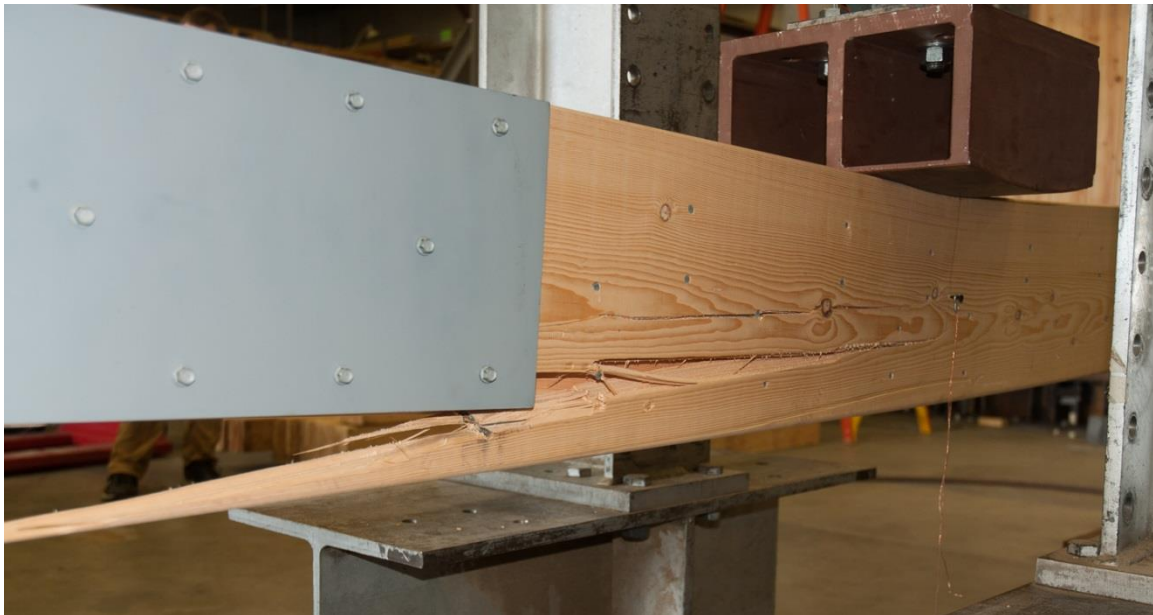
Figure A6. 2x10 3-ply splintering tension failure

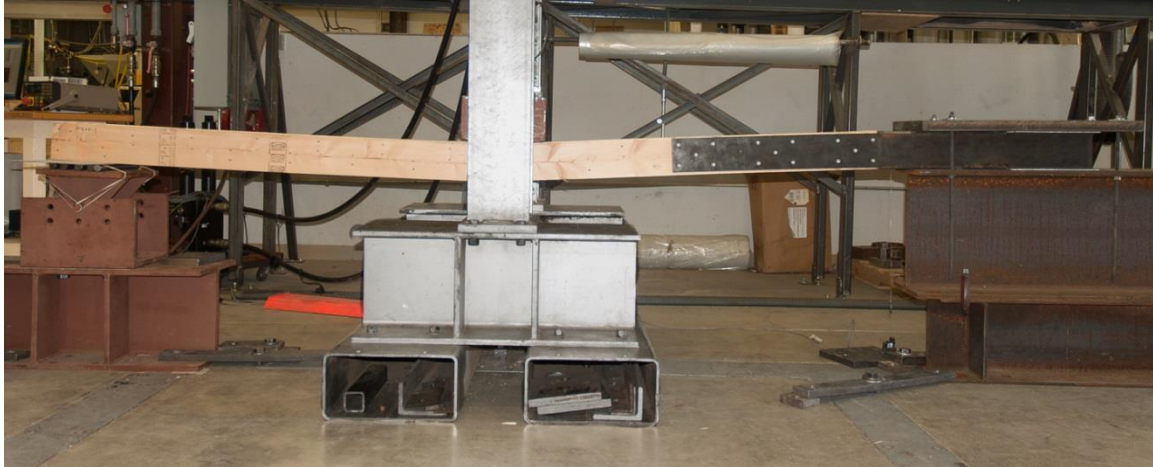
Figure A7. 2x6-4 ply shortly before failure.
